Subject: 2017 Annual Progress Report
South Tacoma Field, Tacoma, Washington
KJ 1796126.00 and 966124.34

Progress Report

SITE NAME: South Tacoma Field, Tacoma, Washington

DATE: Reporting Year 2017

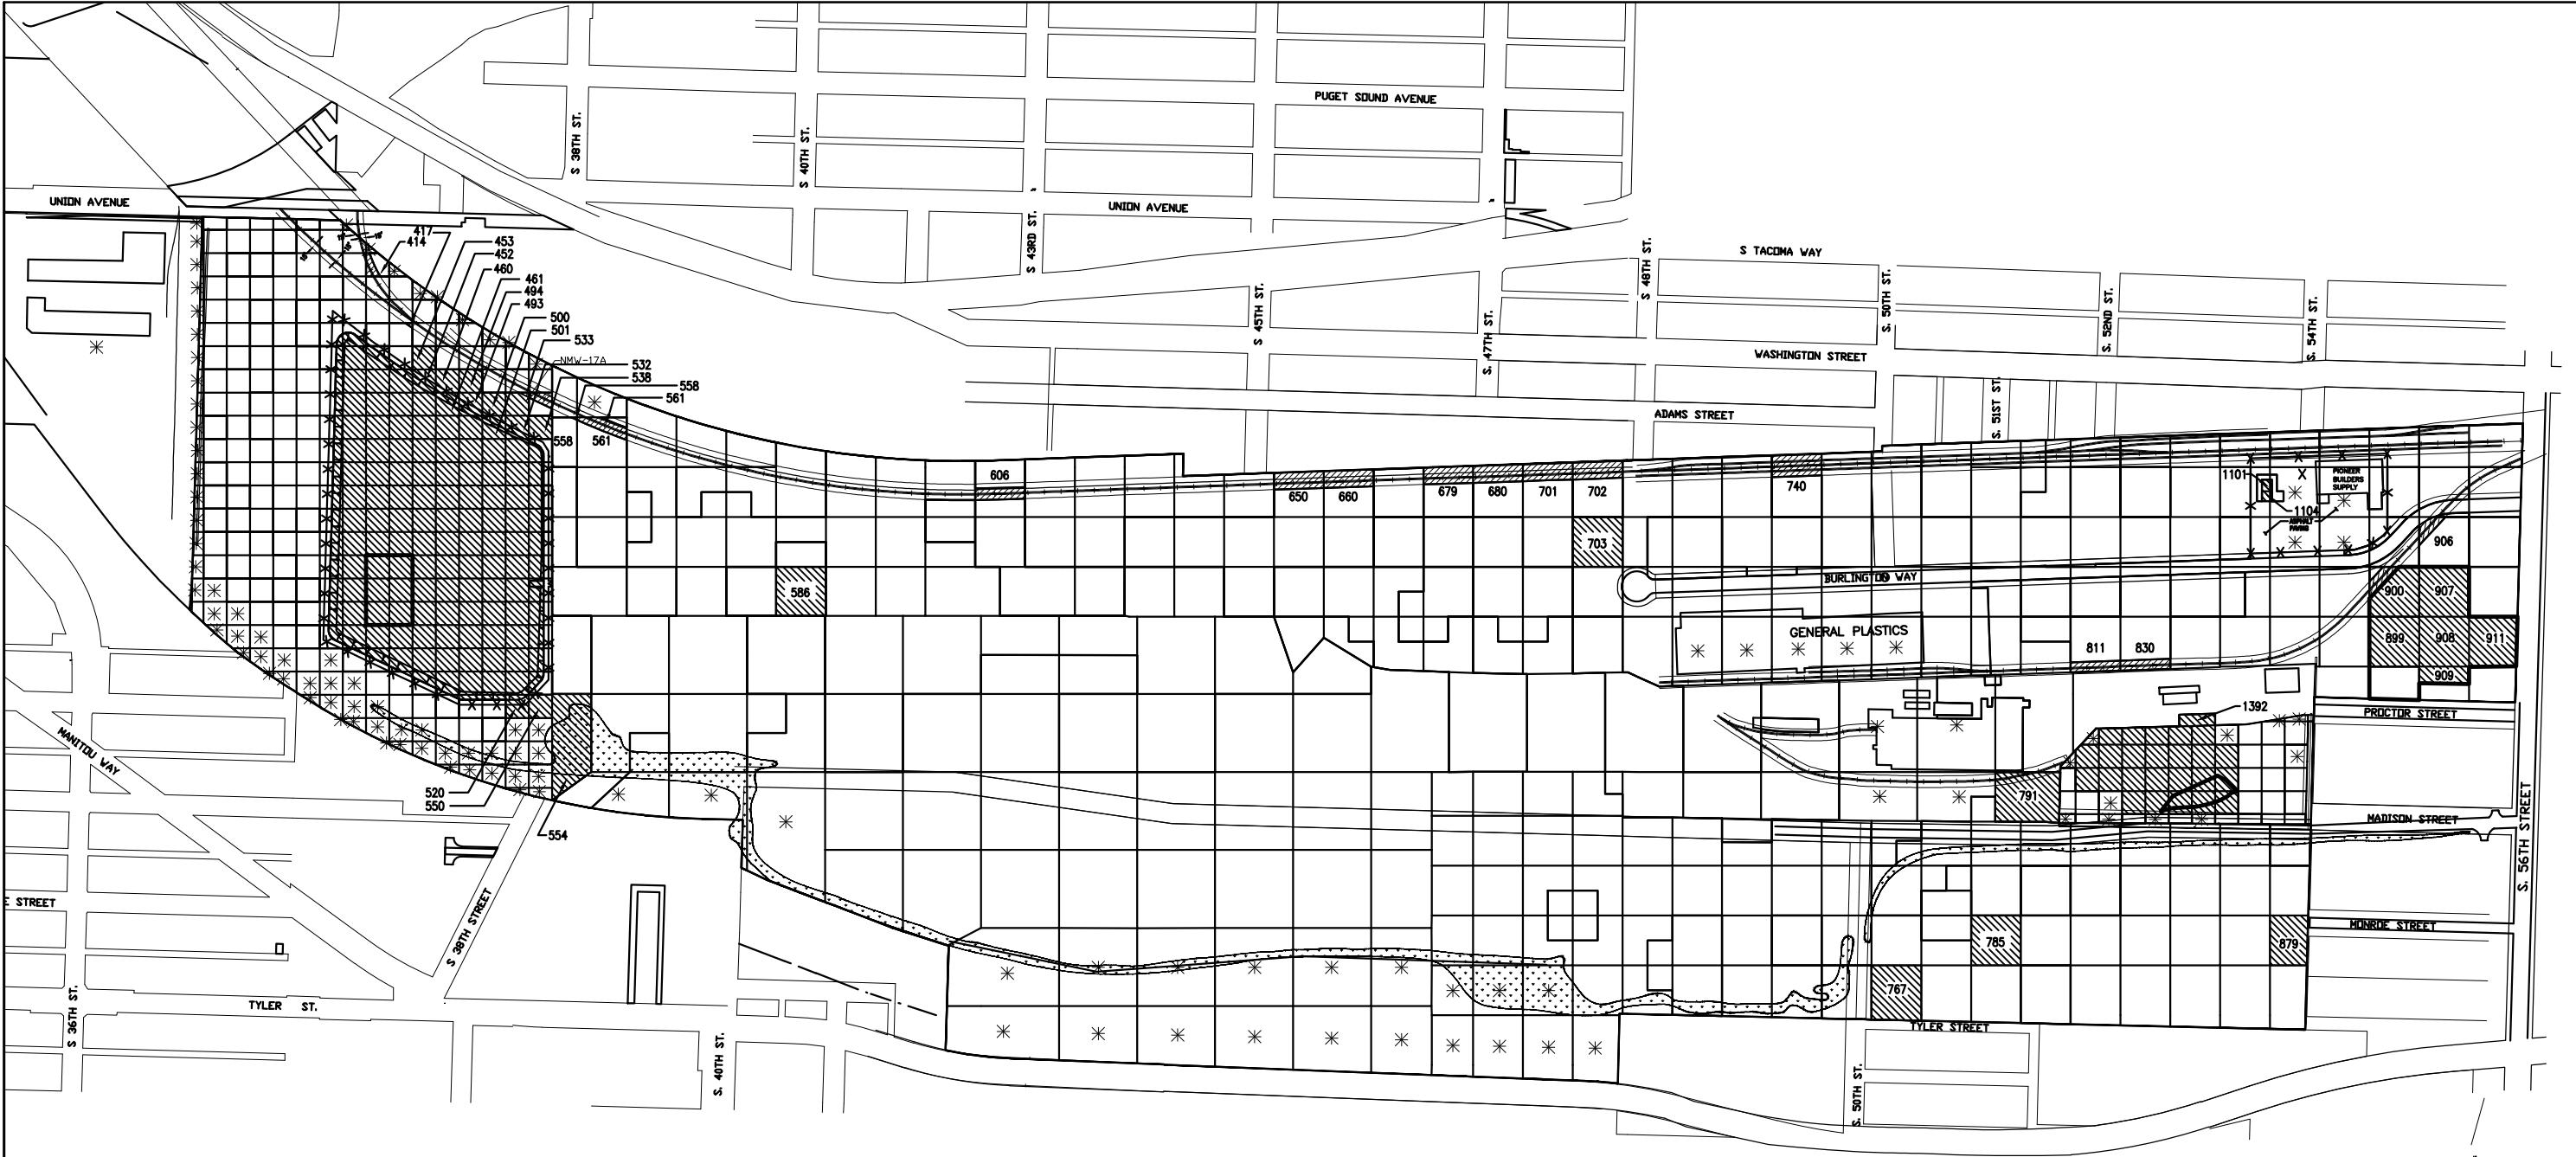
FIGURE 1

- ※ GRID NOT SAMPLED DURING RI OR RA
- 538 GRID ABOVE CAPPING LEVELS; COVERED WITH AT LEAST 1 FOOT OF SOIL OR CAPPED WITH ASPHALT; MAINTENANCE REQUIRED
- 606 GRID POTENTIALLY ABOVE CAPPING LEVELS; NOT REMEDIATED; SAFETY PRECAUTIONS REQUIRED

- 1) NO SAMPLING/REMEDIATION CONDUCTED WITHIN STRUCTURES, BURLINGTON WAY RIGHT OF WAY, OR PAVED AREAS; EXCEPT AS NOTED.

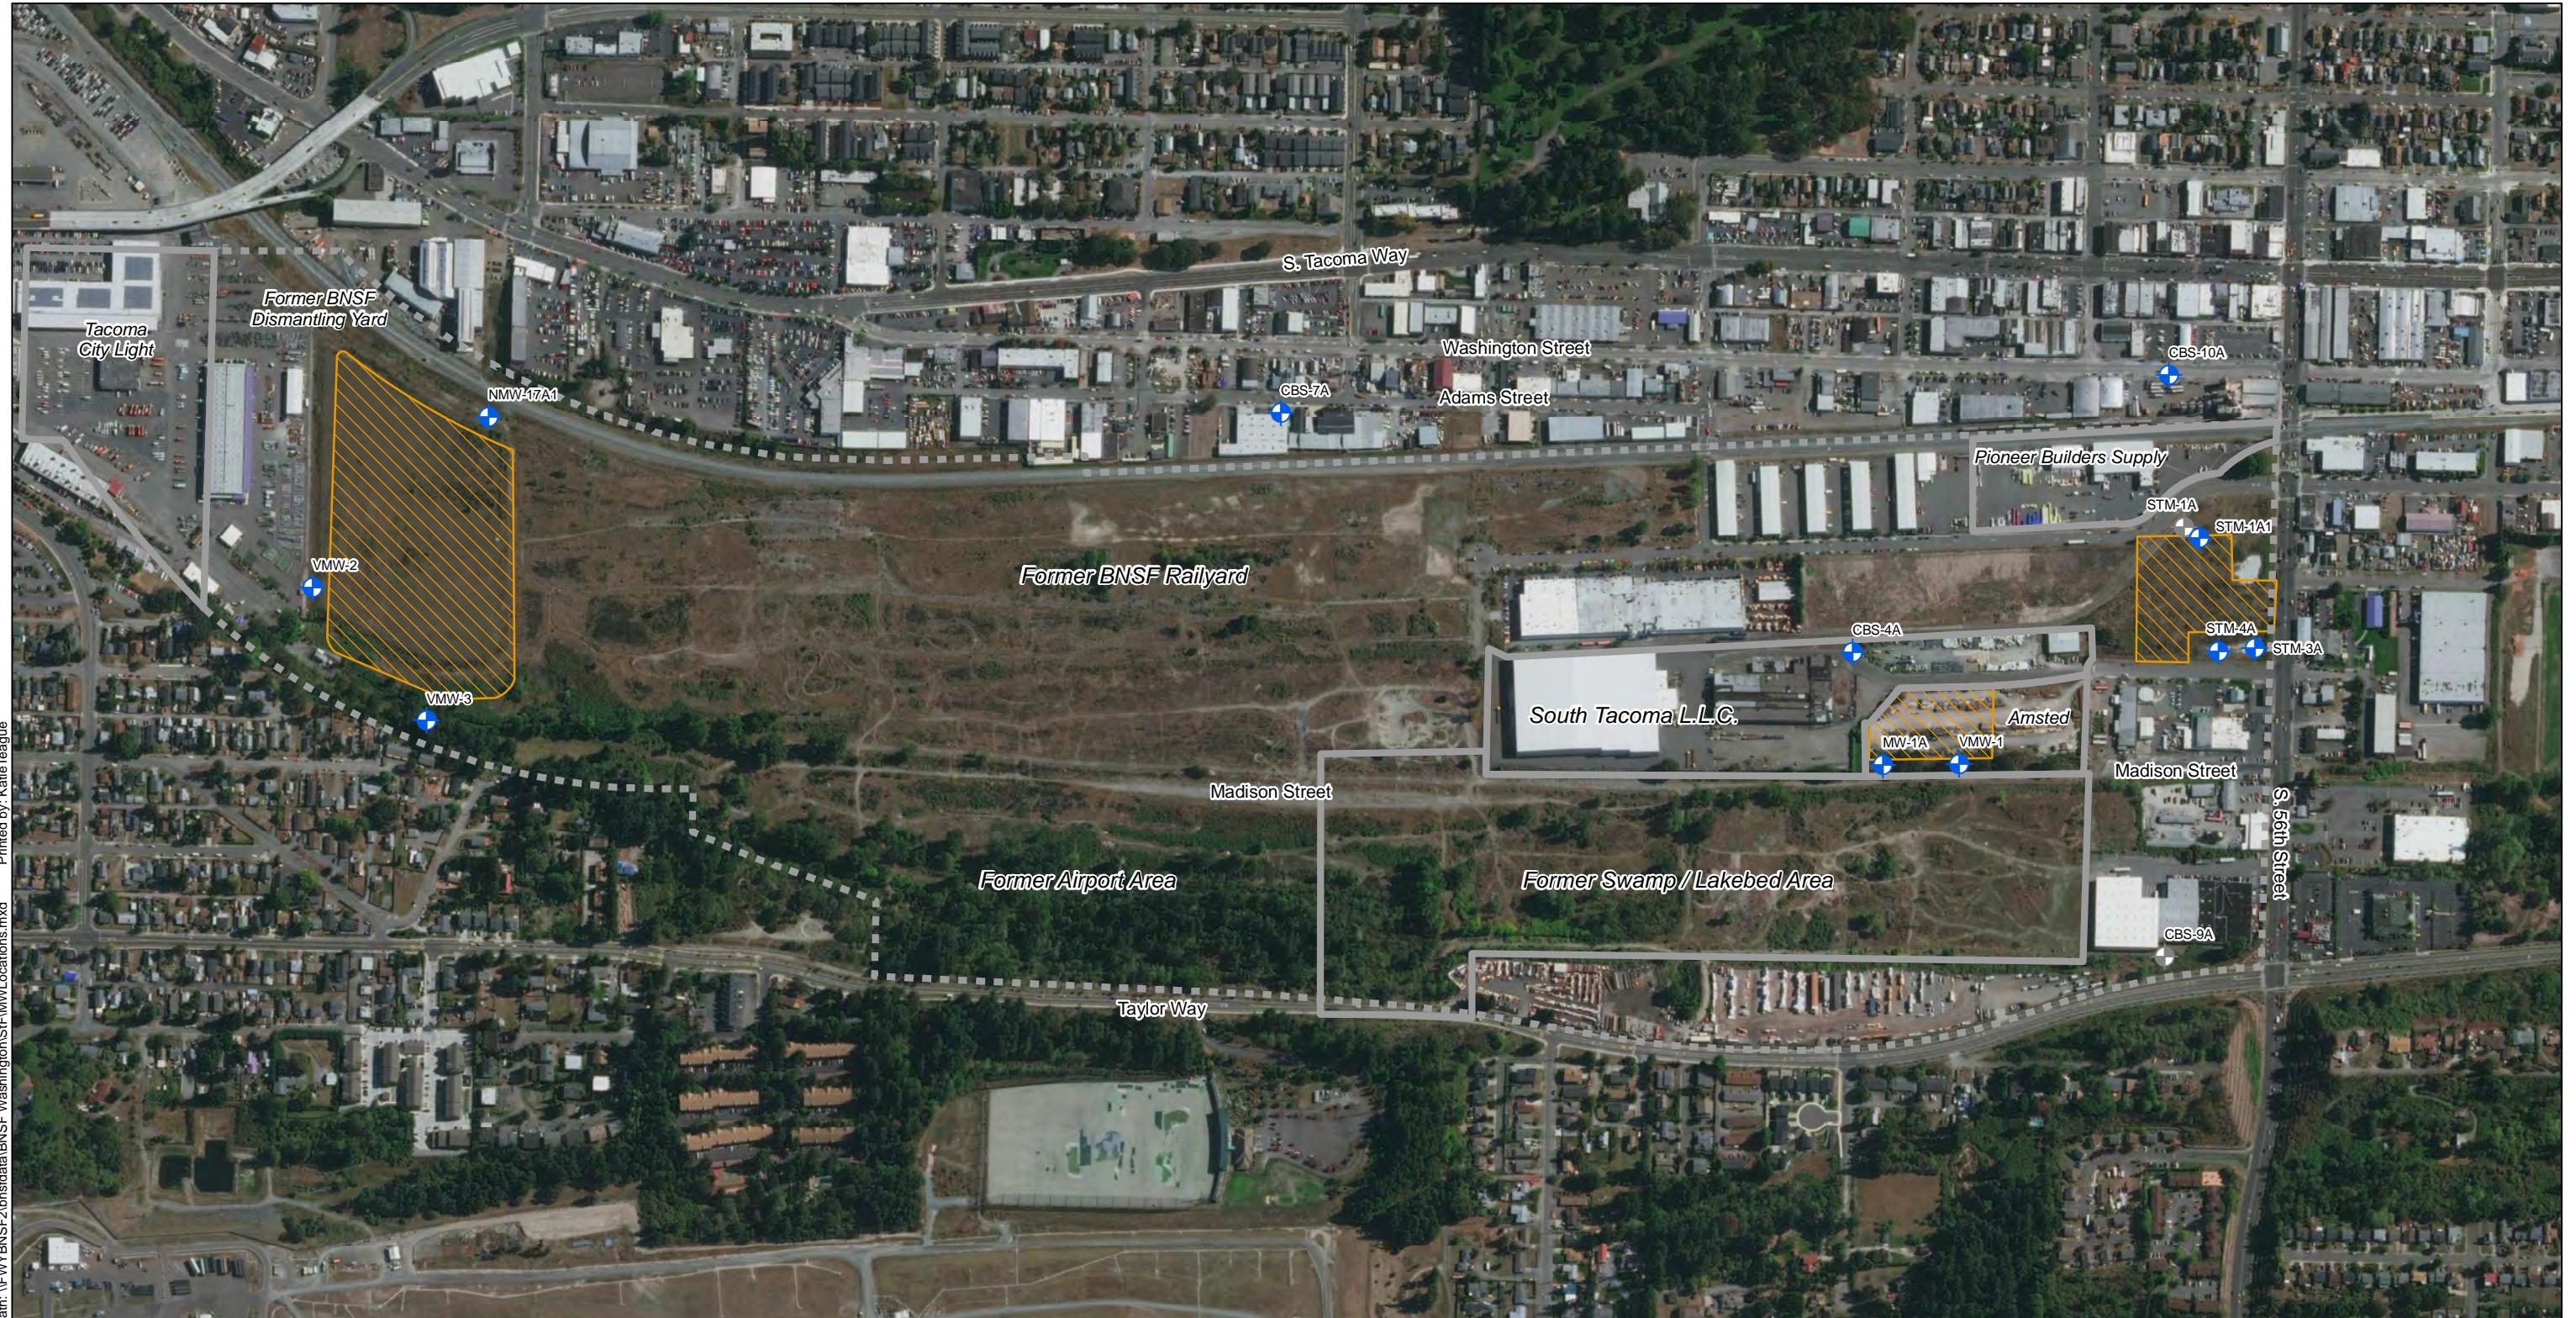
- Monitoring Wells
- ◆ Abandoned Monitoring Wells
- STF-NPL Site Boundary
- Area Boundaries
- Consolidation Area

Kennedy/Jenks Consultants (Kennedy/Jenks) completed one groundwater monitoring event in December 2017 at the BNSF Railway Company (BNSF) South Tacoma Field (STF) and former Amsted Industries sites. Depth to groundwater measurements were collected on 5 December 2017 and monitoring wells were sampled on 4, 5, 6, and 20 December 2017. Groundwater elevations and field water quality parameters are summarized in Tables 1 and 2. Analytical laboratory results are summarized in Tables 3 and 4. Figure 1 illustrates the site maintenance grids. Figure 2 displays the STF and Amsted monitoring well locations and Figure 3 displays the Pioneer monitoring well locations.
